The Effect of Copper on Crevice Corrosion of Stainless Steels

ROGER FRANCIS, FNACE, RFMaterials, Glossop, Derbyshire, United Kingdom
GLENN BYRNE, Rolled Alloys, Blackburn, Lancashire, United Kingdom

Crevice corrosion leaks on superduplex stainless steel sprinkler heads occurred in a firewater sprinkler system operating at 22 °C. Tests showed that copper deposits from corroding copper alloys could act as very efficient cathodes and stimulate dissolution during the regular breakdown and repassivation of the passive film in crevices. Several other service failures have occurred because of a similar mechanism, which had not been previously reported.

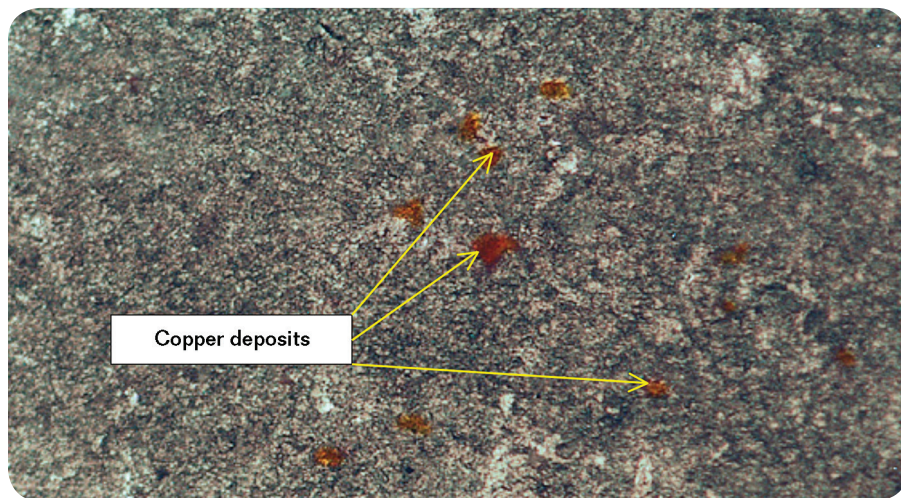
To determine whether this was possible, 50-mm square plates (3-mm thick) were fitted with polyacetal crevice washers, as described in ASTM G78.² The washers were loaded with nylon-coated disc springs to produce a load of 27 N/mm², which provided a tight crevice similar to that found in a screwed joint. The samples were immersed in synthetic seawater containing 50-mg/L cupric ions at 20 °C and the water was continuously aerated with compressed air. After three weeks, the plates were examined and copper deposits were seen outside the crevice (Figure 1). These were confirmed as copper by x-ray analysis using scanning electron microscopy.

FIGURE 1 Copper deposits on superduplex SS after three weeks in aerated seawater plus 50 mg/L cupric ions.

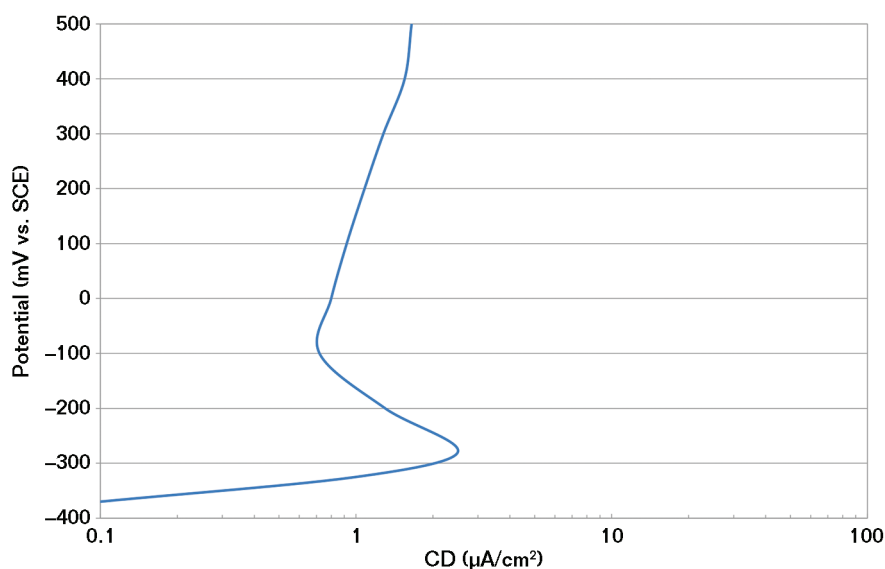
FIGURE 2 Anodic polarization curve for S32760 superduplex SS in 4 M NaCl at pH 1.

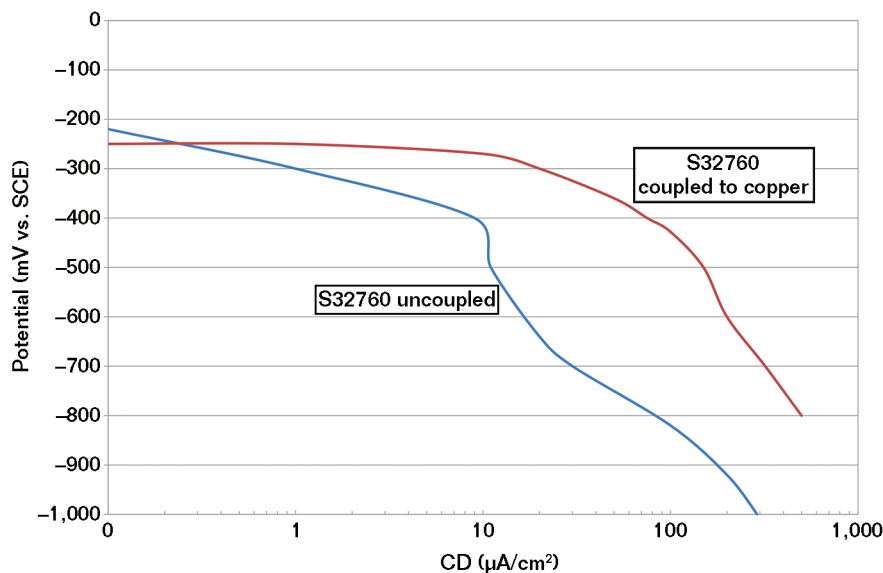
Figure 3 shows the cathodic polarization curves for a S32760 superduplex SS sample (~ 600 mm²) in aerated, synthetic seawater at 20 °C, and also when it is coupled to a ~ 6 -mm² copper sample. The significant depolarization of the cathodic reaction of S32760 when coupled to copper shows the much greater efficiency of copper as a cathode. This is what is believed to have stimulated the initiation of crevice corrosion in the sprinkler heads when repassivation would normally occur.

FIGURE 3 Cathodic polarization curves for S32760 superduplex SS in aerated, synthetic seawater: uncoupled (blue curve) and coupled to ~6 mm² of copper (red curve).
